Lake Shoreland & Shallows Habitat Survey

Grindstone Lake WBIC: 2391200

Sawyer County, Wisconsin

July 2021

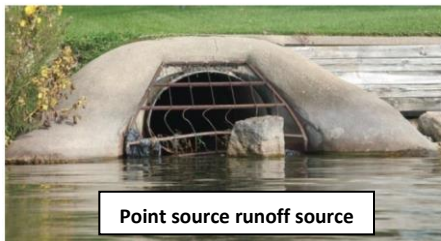
Point source runoff source

- a. Changes that could increase runoff were evaluated. The runoff concerns were identified as within the riparian zone or the parcel but outside the riparian zone. These changes may have included culverts, drain pipes, rain gutters, sump pumps, gray water outflow, channelized flow gullies, stairways, trails, sloped lawn, bare soil, sand/silt deposits, or any other observed concerns.

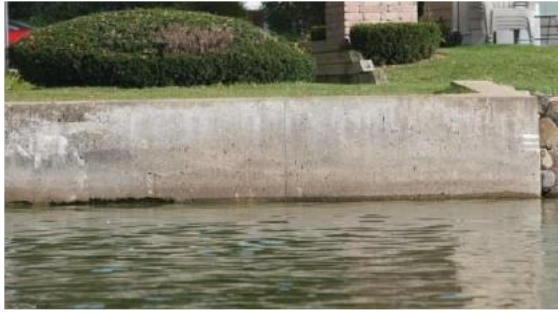
1. Vertical sea wall

The bank zone (space between ordinary high-water mark and present water level (at time of the survey) was evaluated for bank modification and erosion. The length of any modifications and erosion was estimated to the nearest 10 feet. These modifications could include:

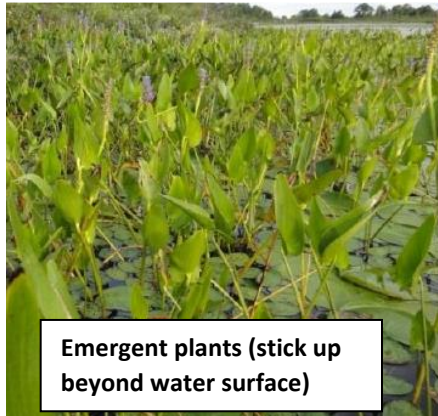
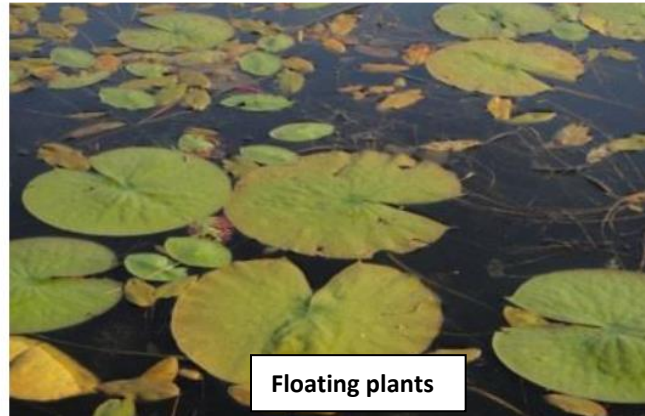
1. Presence of emergent plants-plants that stick up beyond the water surface.
2. Presence of floating plant leaves lay on the water's surface.

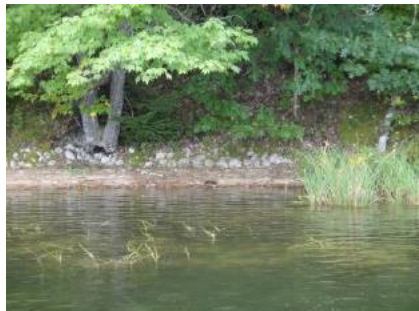
3. Evidence of aquatic plant removal.

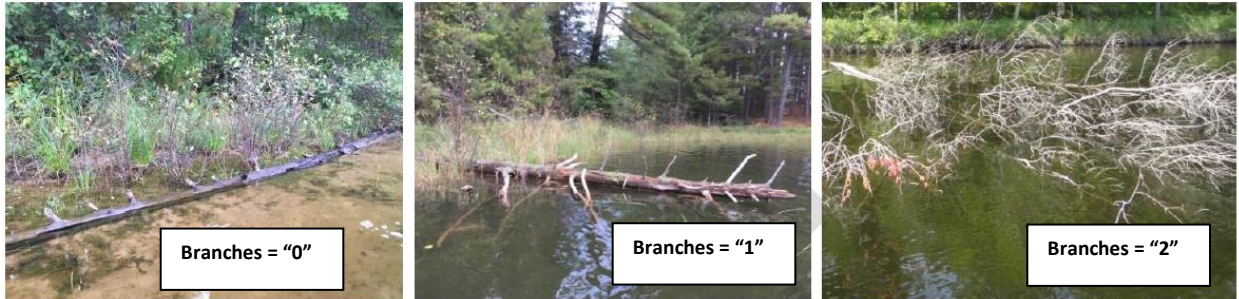
In this portion of the survey, any “large wood” (defined as greater than 4 inches in diameter and at least 5 feet long). GPS coordinates were recorded for any piece of large wood between the ordinary high-water level and 2 feet in water depth. Only dead or alive natural wood (trees) was counted. (Note: Secchi depth needs to be greater than 2ft to record coarse woody habitat. This threshold was met in each lake.)

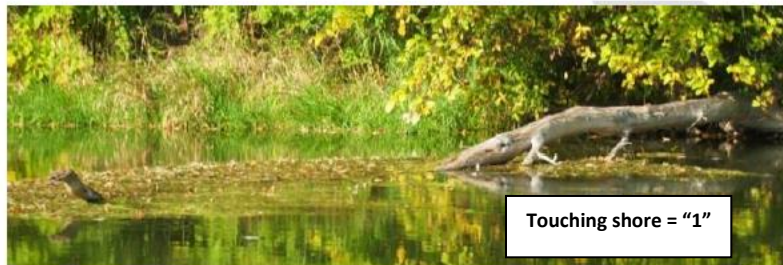
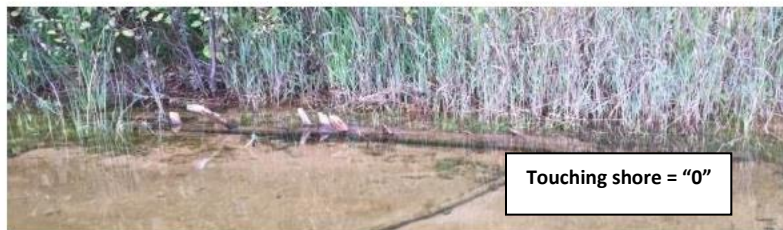
Each coarse woody habitat wood was also evaluated to touch the shore. A “0” was recorded if the log did not cross the high-water level and thus did not come out of the water to the shore. A “1” was recorded if the wood did cross the high-water level and went out of the water and touched the shore. The coarse woody habitat was also evaluated in terms of in the water. It was given a “1” if at least 5 feet of the log is under the water and a “0” if less than 5 feet of the log is under the water.

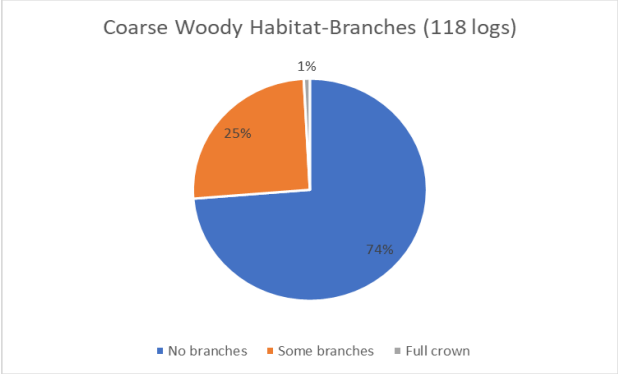
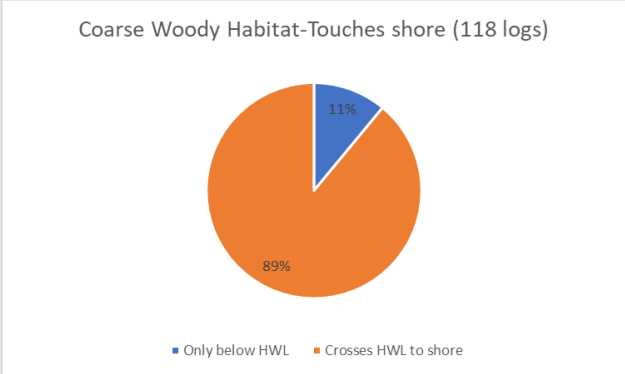
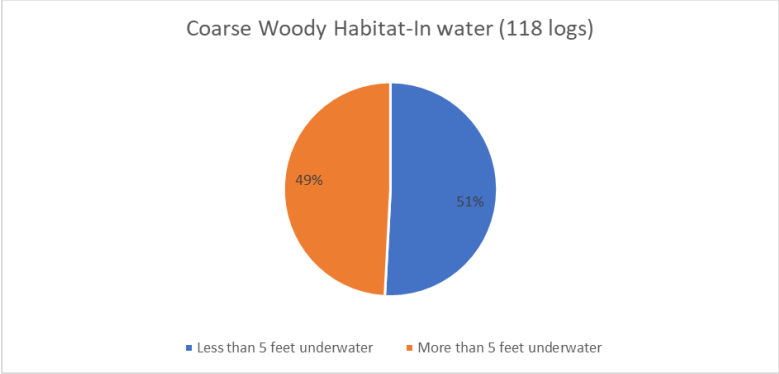
The survey included identifying the amount of branching on the logs if the logs touch the shore above the high-water mark, and how much is under the surface of the water. The table below shows the summary of the various categories.

<i>Each is out of 118 logs recorded</i>	Branches	% of all logs
No branches	87	73.73%
Some branches	30	25.42%
Full crown	1	0.85%
	Touches shore	% of all logs
Only below HWL	13	11.02%
Crosses HWL to shore	105	88.98%
	In water	% of all logs
Less than 5 feet underwater	60	50.85%
More than 5 feet underwater	58	49.15%

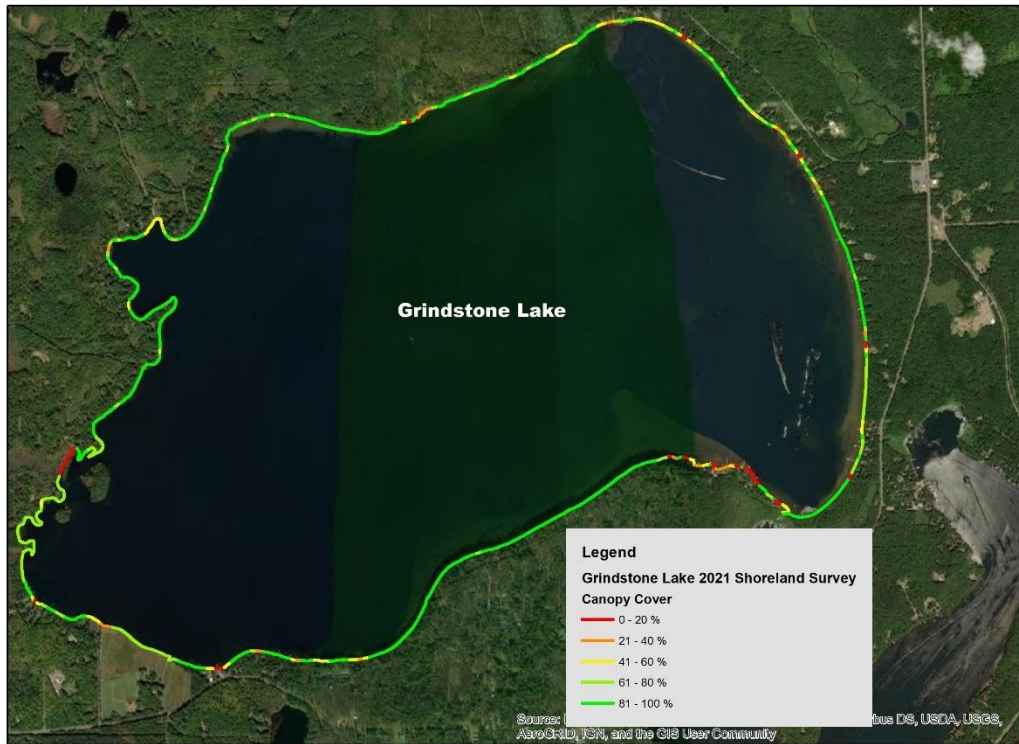
Canopy cover: Less canopy cover can increase runoff and increase erosion.

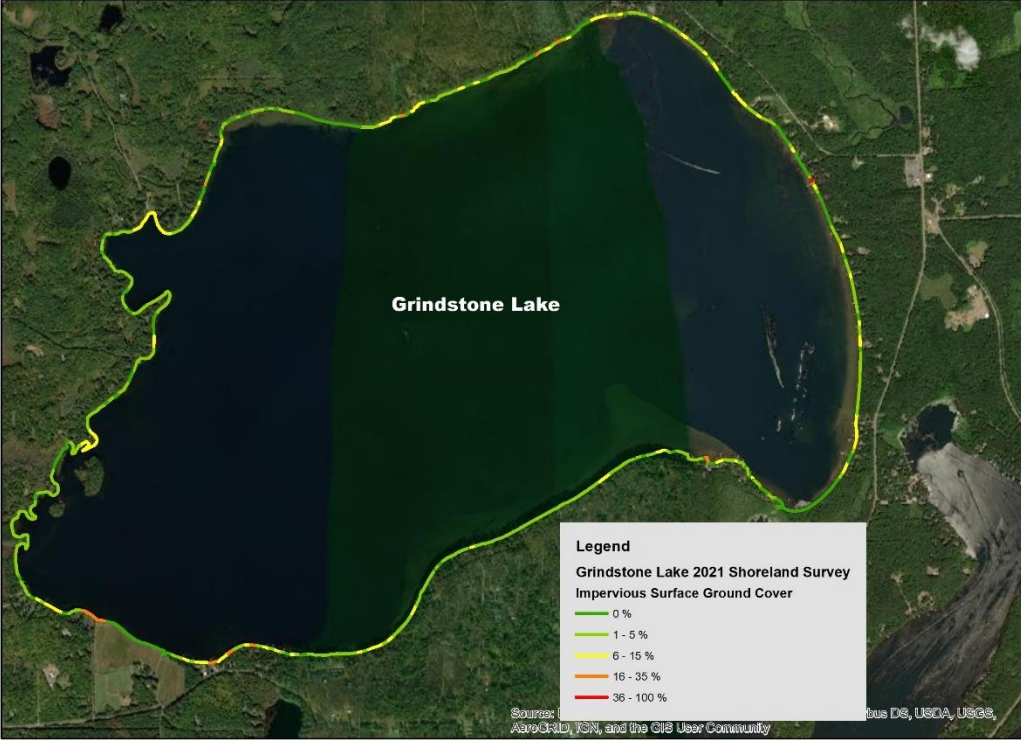
Impervious surface cover: Impervious surfaces do not allow for the infiltration of precipitation. This increases runoff immensely.

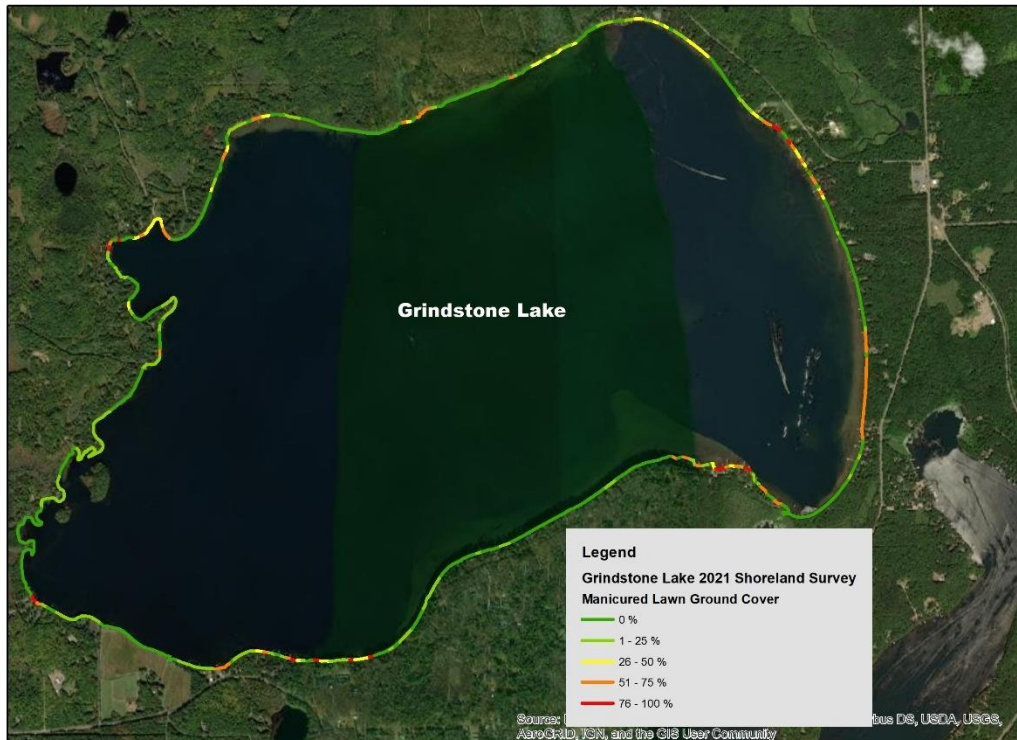
Manicured lawn ground cover: Manicured lawns are less effective in reducing runoff due to limited root structure, shorter height, and fertilization. This can increase runoff and nutrient loading.

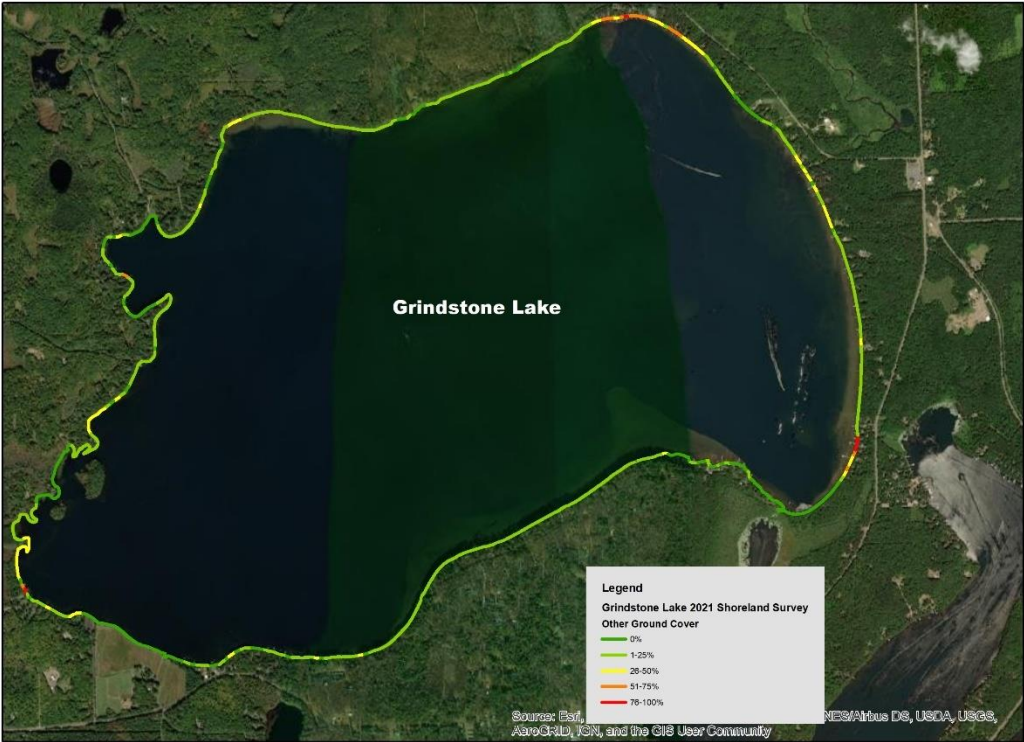
Other ground cover (duff/mulch/soil): This cover indicates little to no plant cover. If the other is bare soil, it can increase erosion and nutrient loading. Duff may be due to extensive tree cover, and mulch is associated with landscape. This may be beneficial depending on the practice for which the cover is being utilized.

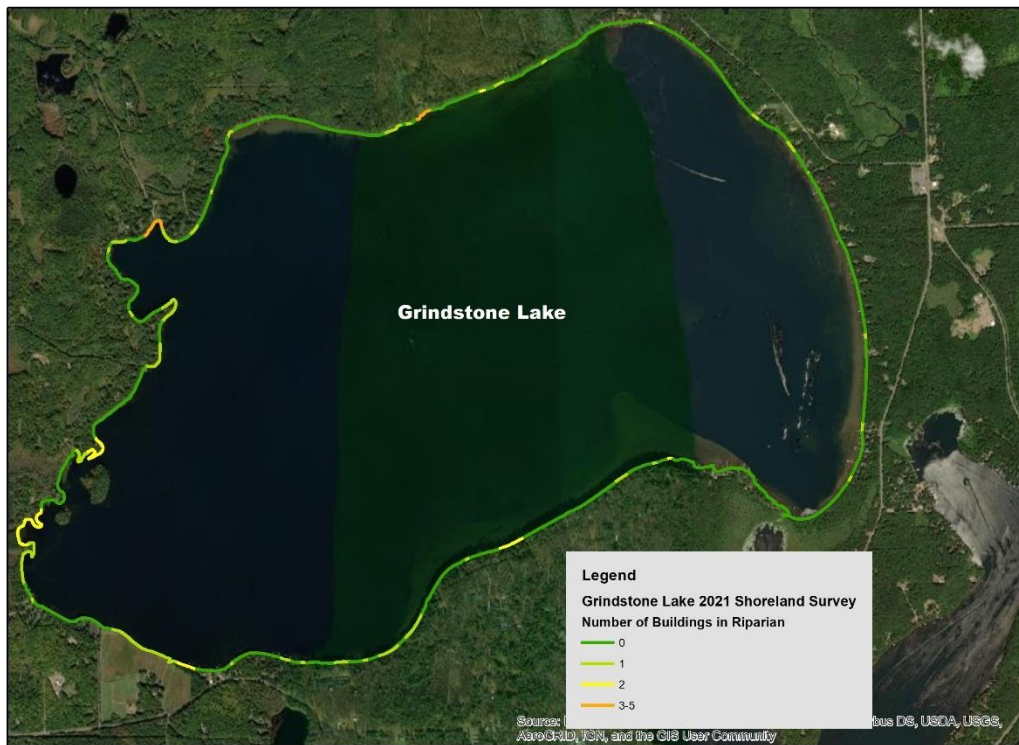
Buildings in the riparian zone: Buildings increase impervious surfaces with the roof. These structures can increase runoff.

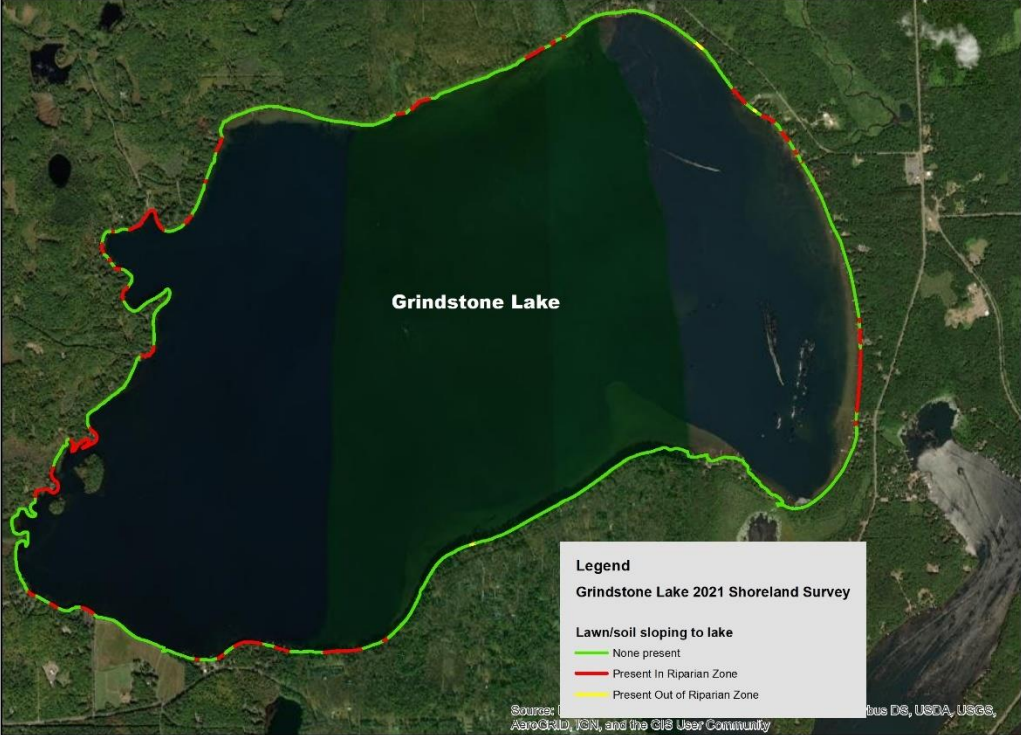
Lawn/soil sloping directly to the lake: If the land cover includes lawn sloping or exposed soil on a slope that runs now to the lake can increase runoff and nutrient loading compared to natural ground cover.

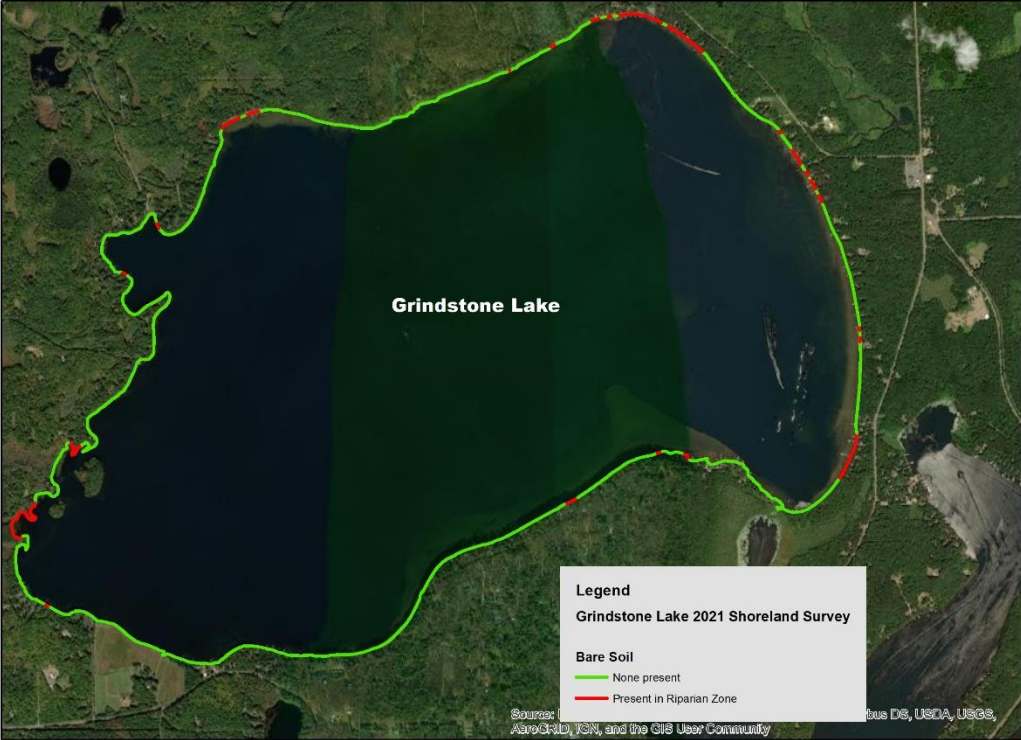
Bare soil: Bare soil implies that there is no ground cover. Bare soil is prone to erosion which can increase runoff and nutrient loading.

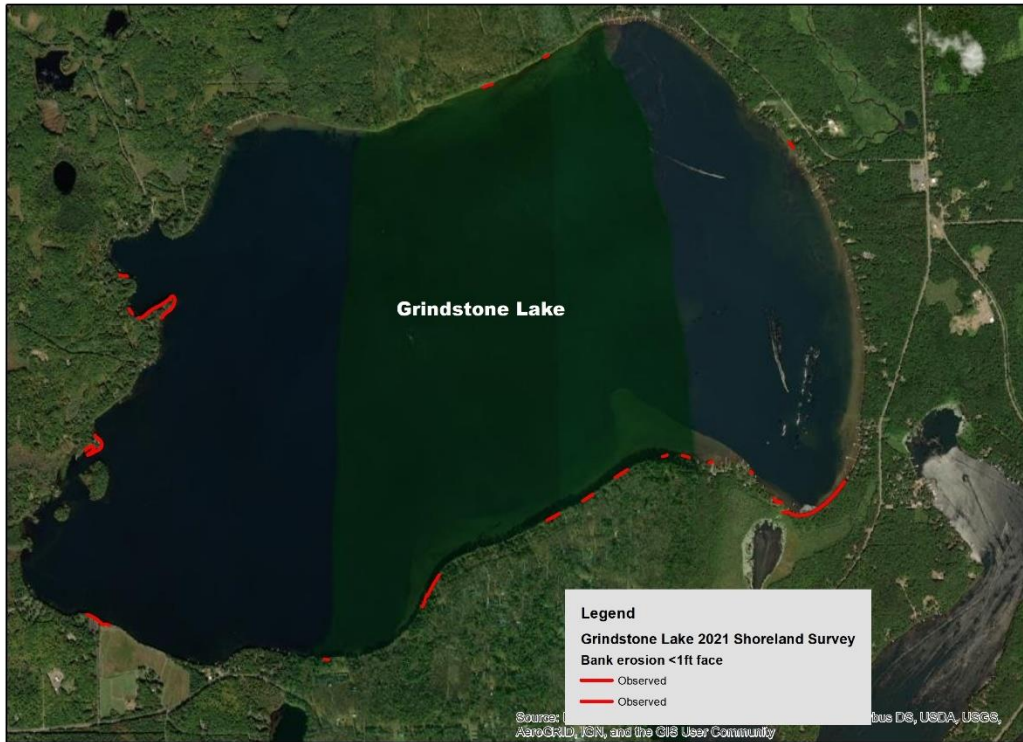
Bank erosion with < 1ft face: Bank erosion can lead to sedimentation. Phosphorus is typically associated with sediment, therefore increasing nutrient loading and water runoff potentially increasing.

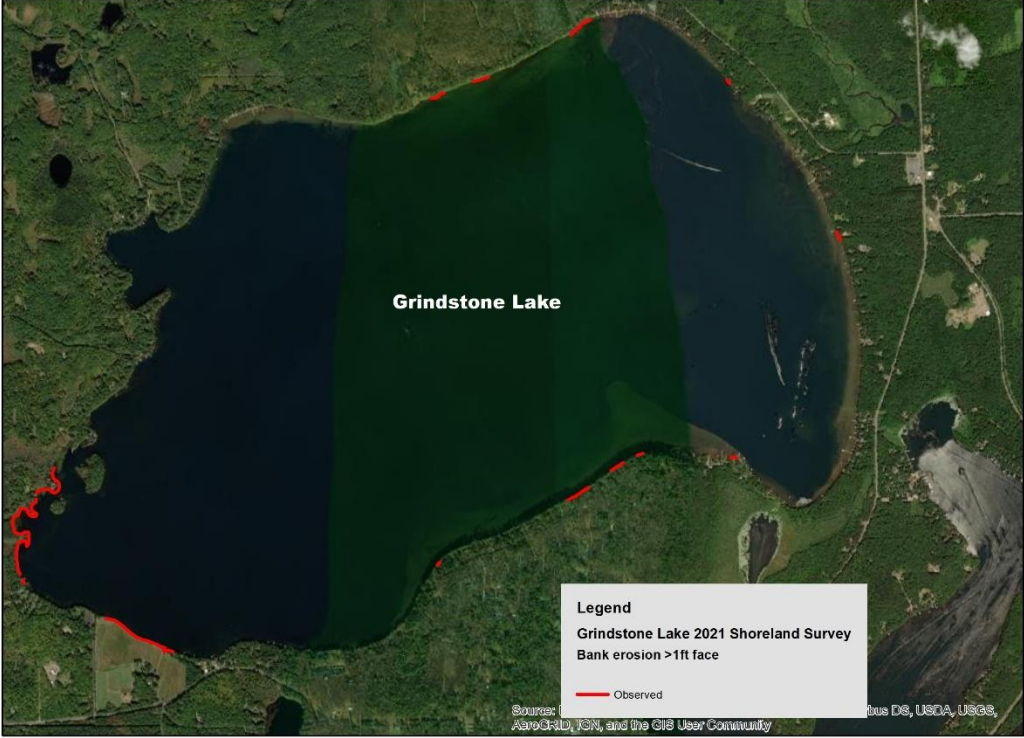
Bank erosion with > 1ft face: Bank erosion can lead to sedimentation. Phosphorus is typically associated with sediment, therefore increasing nutrient loading and water runoff potentially increasing. The larger face indicates more intense erosion.

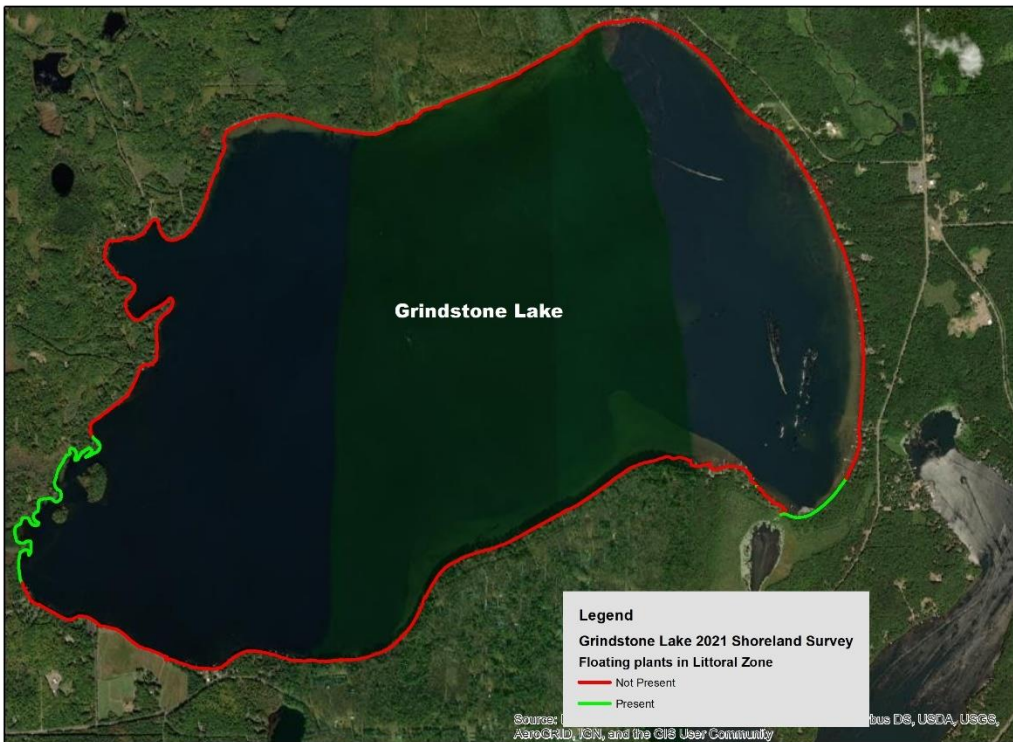
Floating plants present: It is desirable to have floating plants in the littoral zone. They provide cover and habitat for a myriad of lake organisms. These plants can also reduce wave energy and stabilize lake sediments.

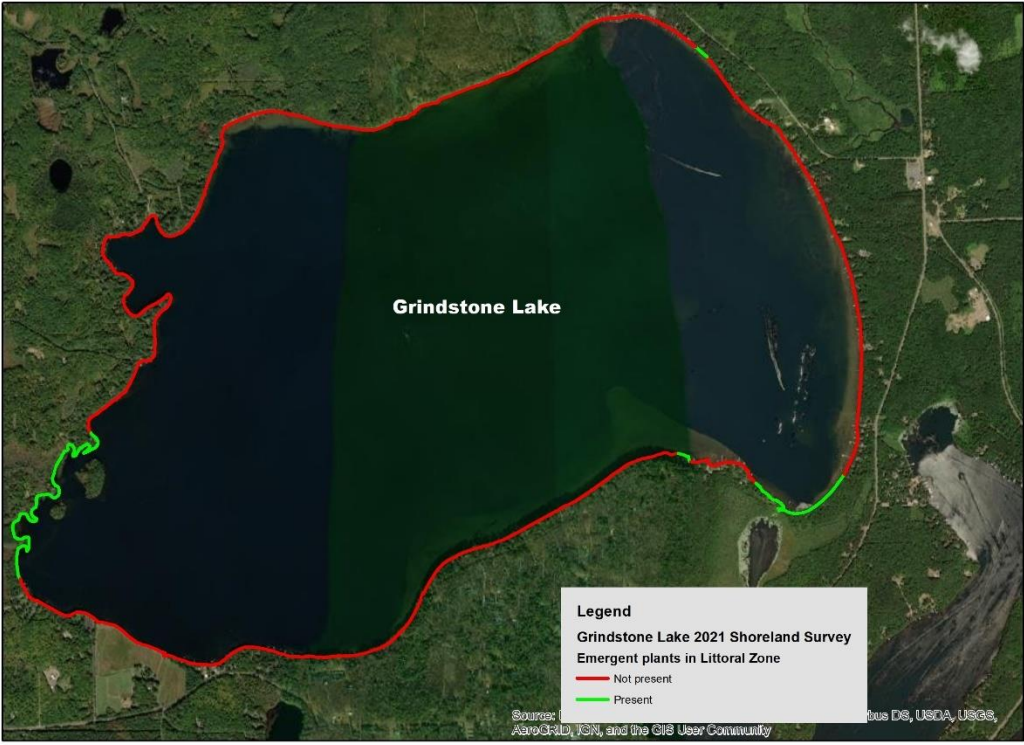
Emergent plants present: Emergent plants stick out beyond the lake surface. They provide cover for many organisms including larger species such as waterfowl, birds, and aquatic mammals. Emergent plants can also reduce wave energy bank erosion and stabilize lake sediment.

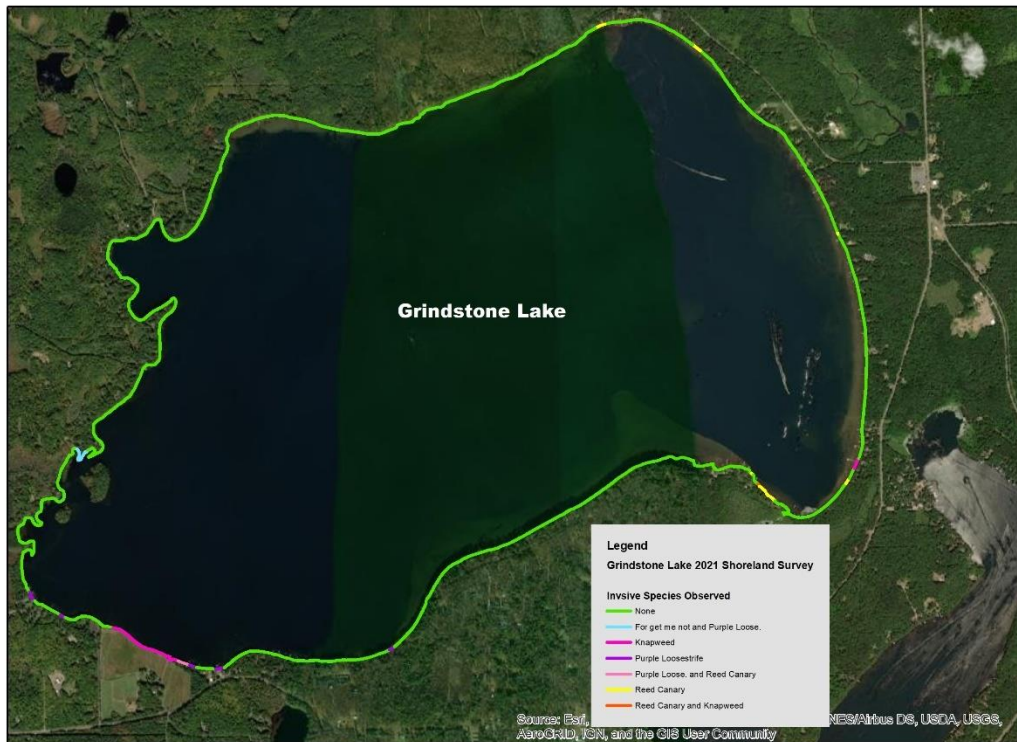
Aquatic invasive species (AIS): Aquatic invasive species (and terrestrial species) can out-compete native plants and reduce diversity in ecosystems. The plants are observed in the riparian zone, which an aquatic plant survey may miss.
